STRUCTURAL CONDITION REVIEW REPORT

DATE: 28 December 2022

PROPERTY: Carleton Villa, Carleton Island, Cape Vincent, NY

KHH NO: 122087

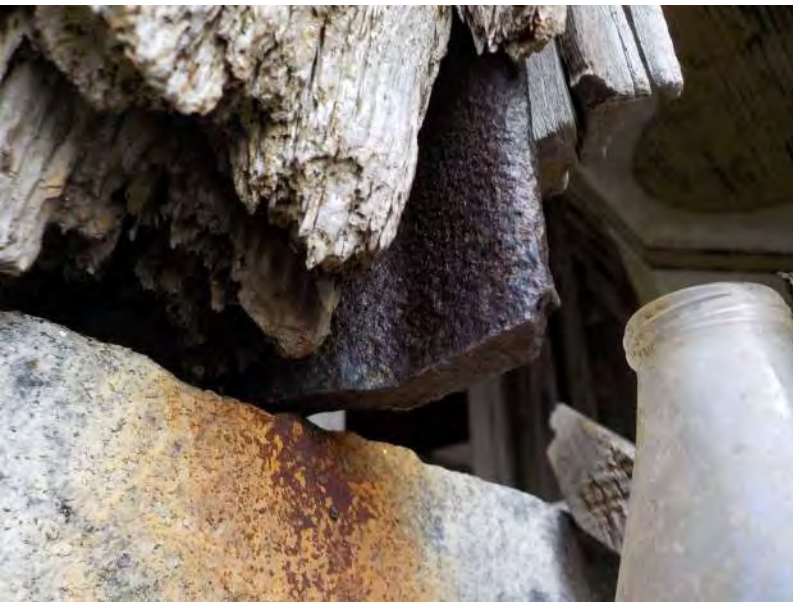
040 - Exterior masonry - Deteriorated support at window 1.jpg

- 3.1.9.1 The stone sill had fallen off the building. See Photo 040.
 - 3.1.9.2 The vertical steel angle posts that had been built into the window mullions were rusting and created undistributed point loads on the stone sills. This may have created some degree of settlement of the lintel at the second-floor level. See Photos 040 and 041.

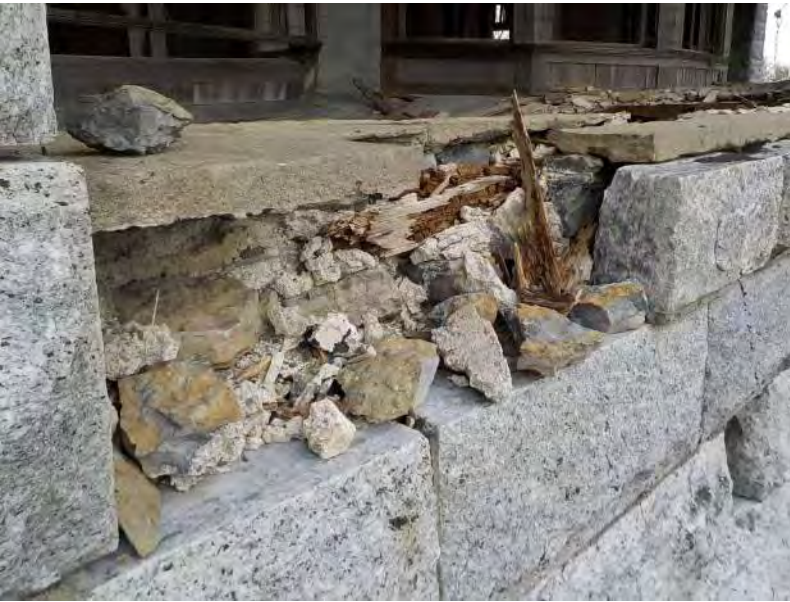
042 - Exterior masonry - Cut stone at perimeter walls.jpg

- 3.1.10 The perimeter rough-finished stone masonry walls surrounding the building and extending up to the first floor or first floor porch elevation varied in condition from fair to good, to poor. Several areas had local collapsed conditions, especially along the northwest building face. See Photos 042 through 045.

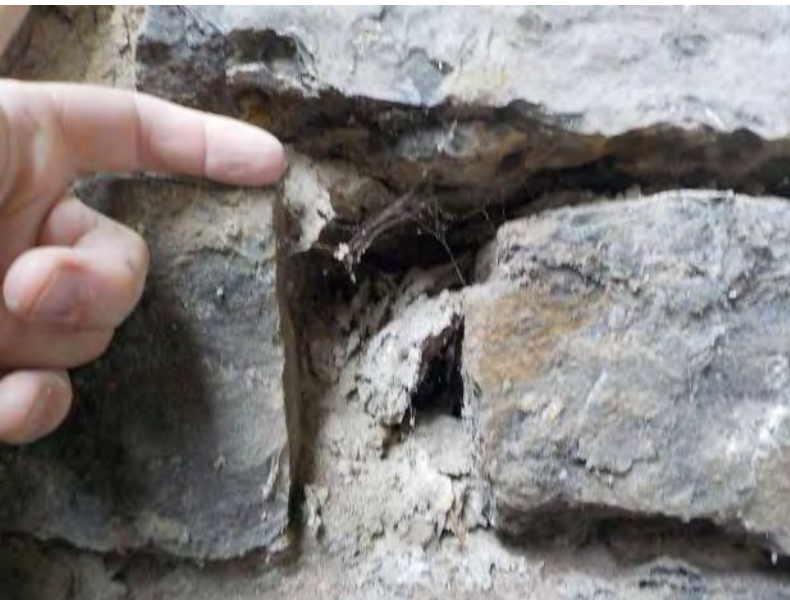
046 - Masonry - Condition of mortar joints 1.jpg

- 3.1.11 The mortar joints between the stones were generally in poor condition with most of the mortar joints cracked, broken, deteriorated, loose, or missing. Various colors, strengths, and compositions of the existing mortar were present. In some areas, I was able to remove a section of mortar and found that there was sand, or disintegrated mortar, behind the intact mortar. See Photos 046 through 056.

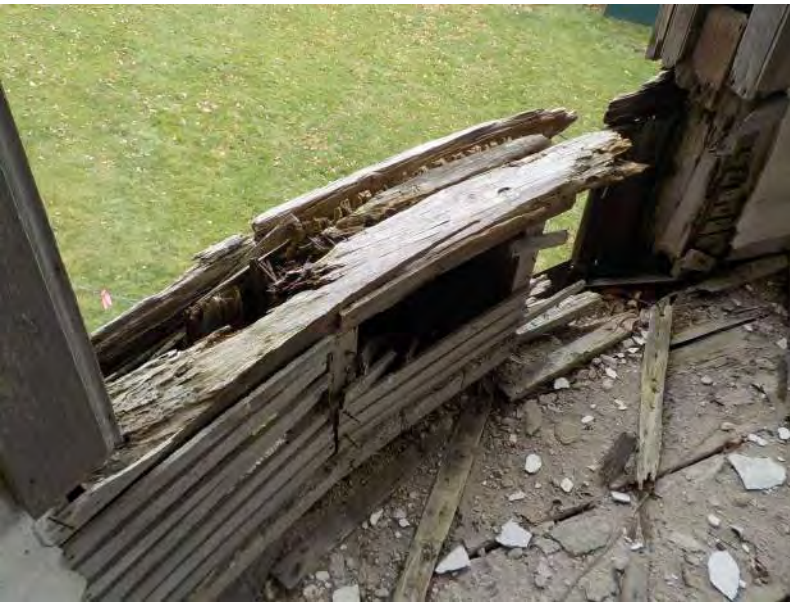
098 - Second floor deteriorated walls.jpg

3.4.3.2 Several of the exterior wall areas were severely deteriorated. The northwest portion of the southwest wall had diagonal cracks in the plaster finish. See Photos 098 through 102.

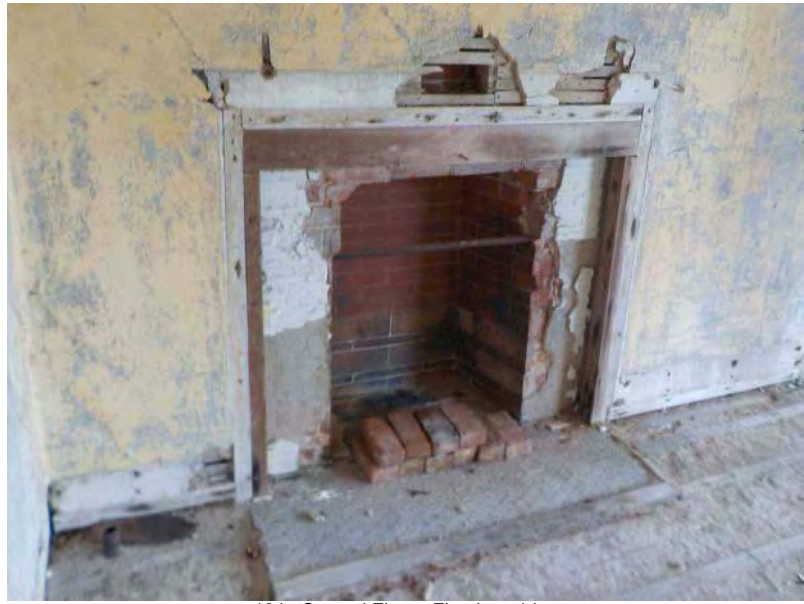
103 - Second Floor - Deteriorated interior wall.jpg

3.4.3.3 Several of the interior walls were severely deteriorated. See Photos 103.

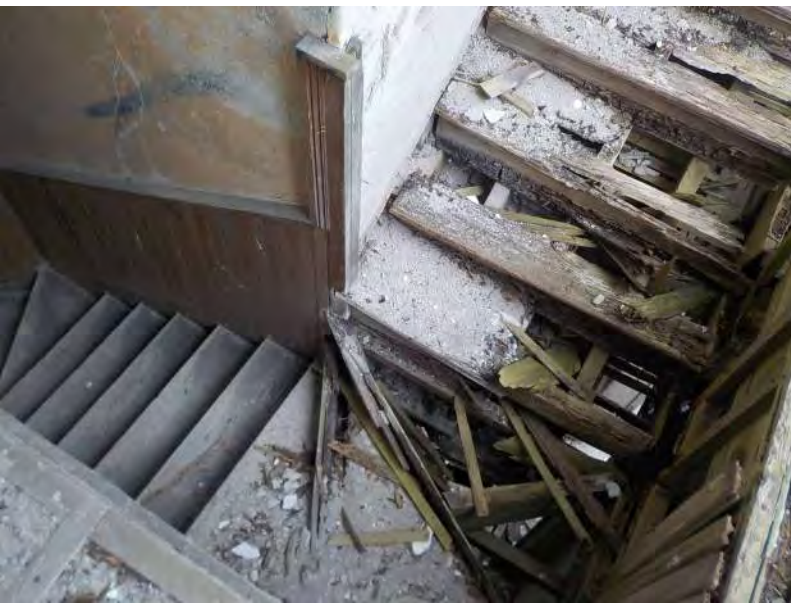
114 - Second Floor - Overview of floor 9.jpg

3.4.3.5 Much of the second floor had areas of holes, sags, or apparent deterioration. See Photos 106 through 114.

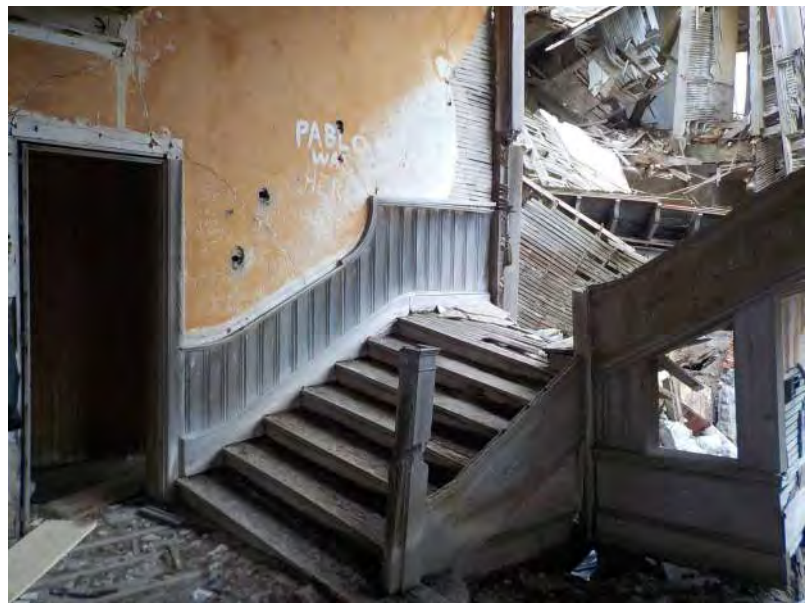
115 - Second Floor - Deteriorated secondary staircase.jpg

3.4.3.6 The secondary staircase between floors 1 and 2 was extremely deteriorated. See Photo 115.

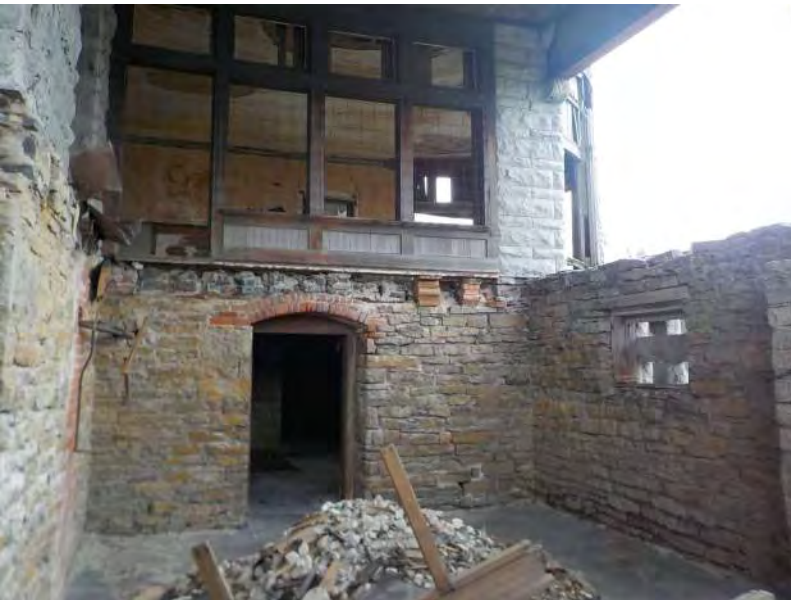
134 - First Floor - Overview of floor 8.jpg

3.4.4.4 Much of the first floor had areas of holes, sags, or apparent deterioration. See Photos 127 through 134.

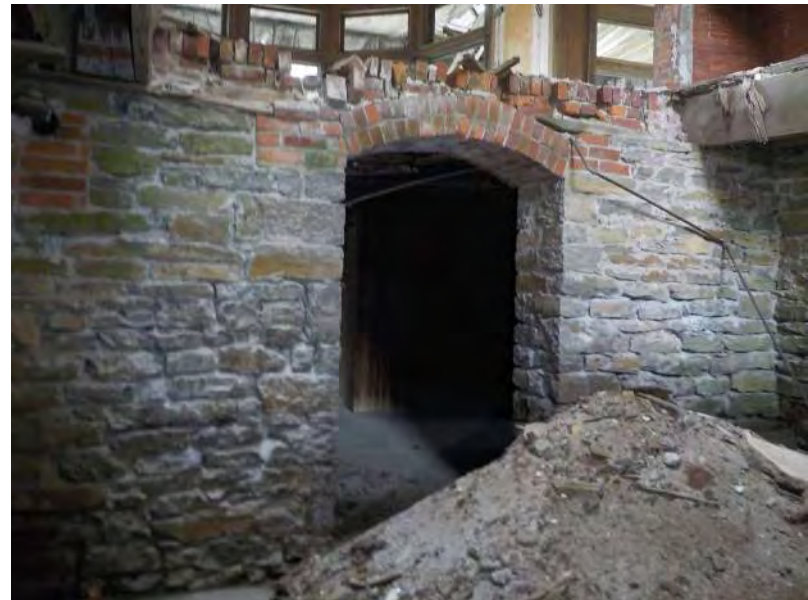
135 - Basement - Missing first floor at south corner.jpg

3.4.4.5 A section of the first floor exterior porch at the south corner of the building was missing. See Photos 135 through 138.

3.5.1 The masonry basement walls, visible from the basement, were in fair condition. The exterior walls and most of the interior walls were mortared fieldstone, with some of the interior walls mortared brick. The wall surfaces exhibited no significant tilting or bowing, and with limited exception, the stones in the wall were intact. Most of the mortar joints were cracked, deteriorated, or missing. See Photos 135, 136, 137, 141, and 143.
