STRUCTURAL CONDITION REVIEW REPORT

DATE: 28 December 2022

PROPERTY: Carleton Villa, Carleton Island, Cape Vincent, NY

KHH NO: 122087

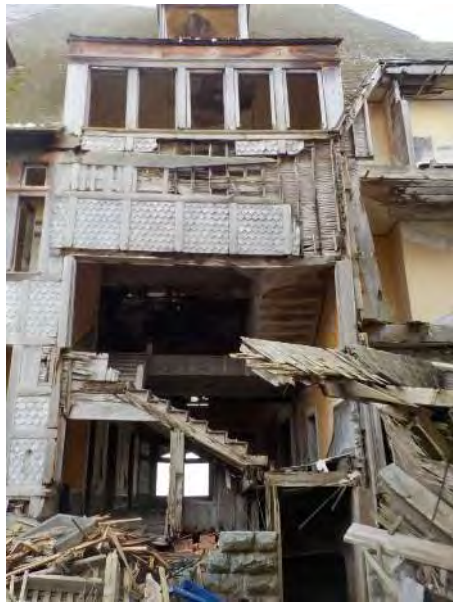
015 - Upper building exterior overview 10.jpg

3.1.2.3 Some local areas of the walls were missing. A large area of the northeast-facing wall from the main stairs to the northwest, adjacent to the collapsed area at the northeast end of the building site was missing – some or all of this wall area had formerly been an interior wall. See Photos 015 and 016.

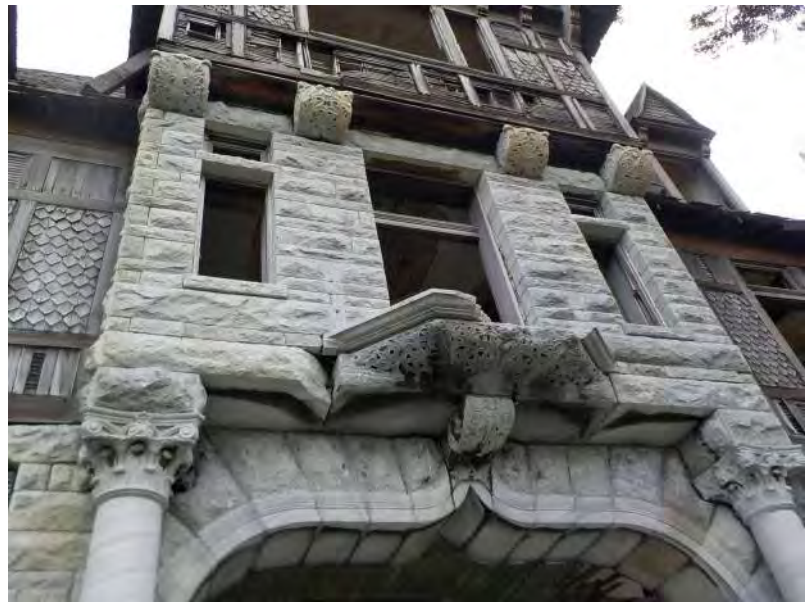
018- Exterior masonry - SW portico masonry 1.jpg

- 3.1.3.1.1 Four ornamental cut stone corbels at the third floor – good condition. See Photo 018.
- 3.1.3.1.2 Lintel stones over the three second-floor window openings – good condition. See Photo 018.

- 3.1.3.1.3 Second-floor stone wall and stone sills for the three window openings – good condition. See Photos 018 and 019.
- 3.1.3.1.4 Projecting cut stone central element at the second-floor elevation – a large section was missing from the central stone element and an exterior corner of the horizontal stone element to the northwest, with a rusted iron anchor bar visible. See Photos 018 and 019.

- 3.1.3.1.5 Two Corinthian-order stone columns adjacent to portico – good condition. See Photos 018, 020, 022, 023, and 025.
- 3.1.3.1.6 Cut stone pointed arch between columns, with rough-faced stone masonry wall above – fair to good condition with some pieces cracked and extensive dark staining. See Photos 018 through 021.

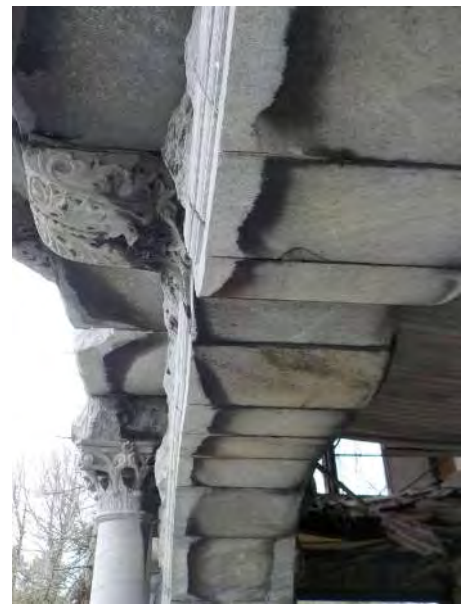
020 - Exterior masonry - SW portico masonry 3.jpg

- 3.1.3.2 The wood ceiling of the first-floor porch, which likely provides lateral bracing to the two-story stone wall, was in poor condition. See Photos 020 and 021.

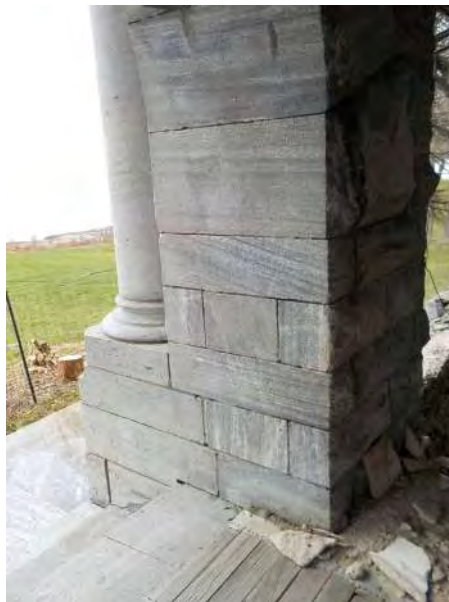
023 - Exterior masonry - SW portico masonry 6.jpg

- 3.1.3.1.7 Cut stone piers behind columns – fair to good condition with a few stones cracked. See Photos 023 and 024.

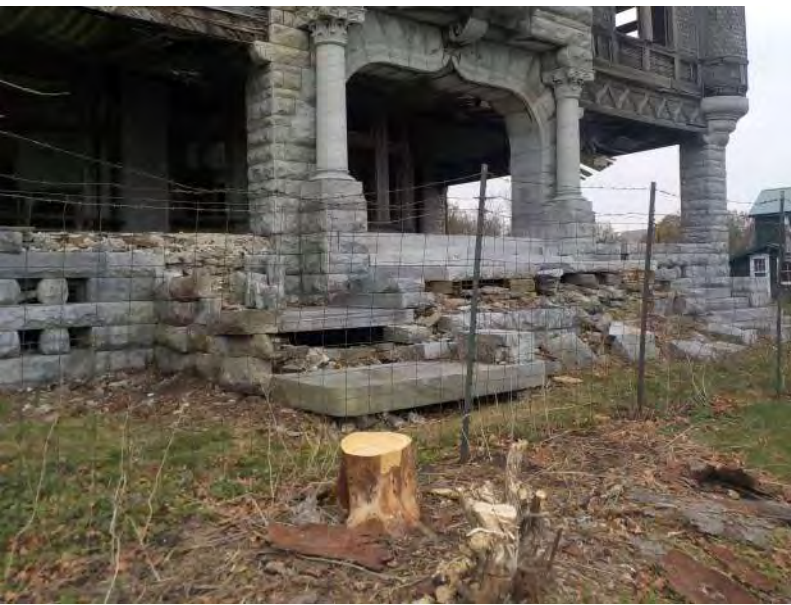
025 - Exterior masonry - SW entrance 1.jpg

- 3.1.4 Stone Masonry Exterior Entry Elements at Southwest Porch
 - 3.1.4.1 The top of the stone masonry basement wall in the area of the southwest porch as well as the adjacent stone staircase with side cheek walls that lead from grade up to the first floor porch, were in poor condition with extensive dislocation of the stone elements and broken stone pieces. See Photos 025 through 032.

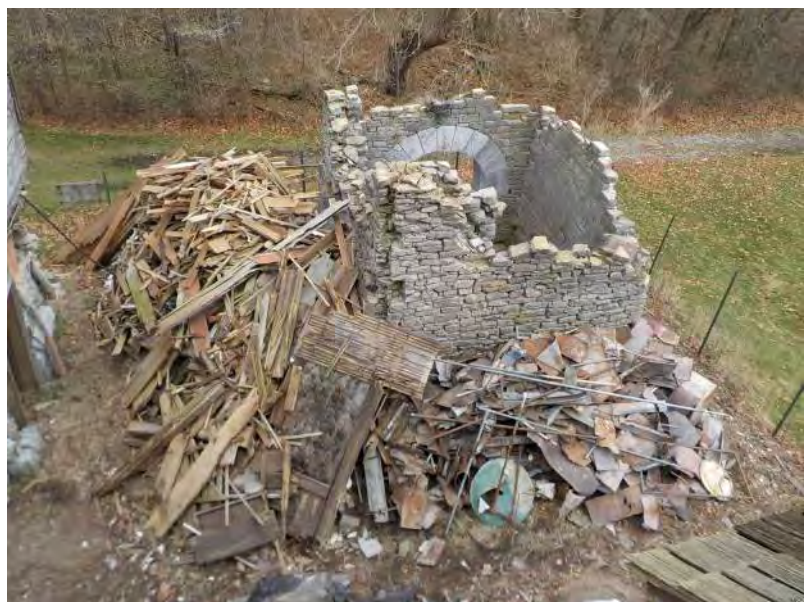
058 - Northeast Area - Base of tower.jpg

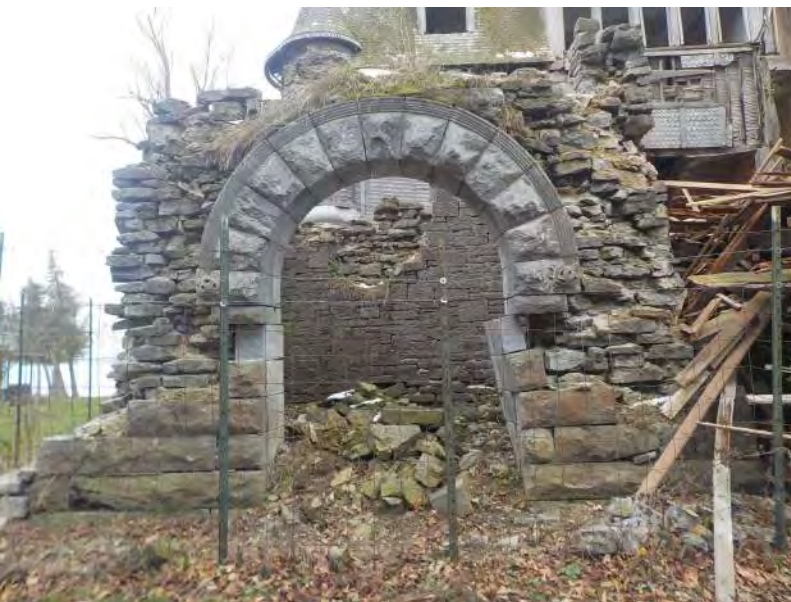
059 - Northeast Area - NE stone arch.jpg

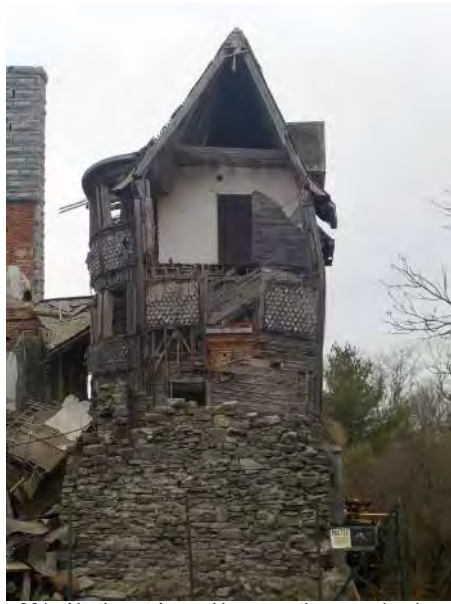
061 - Northeast Area - Upper section overview.jpg

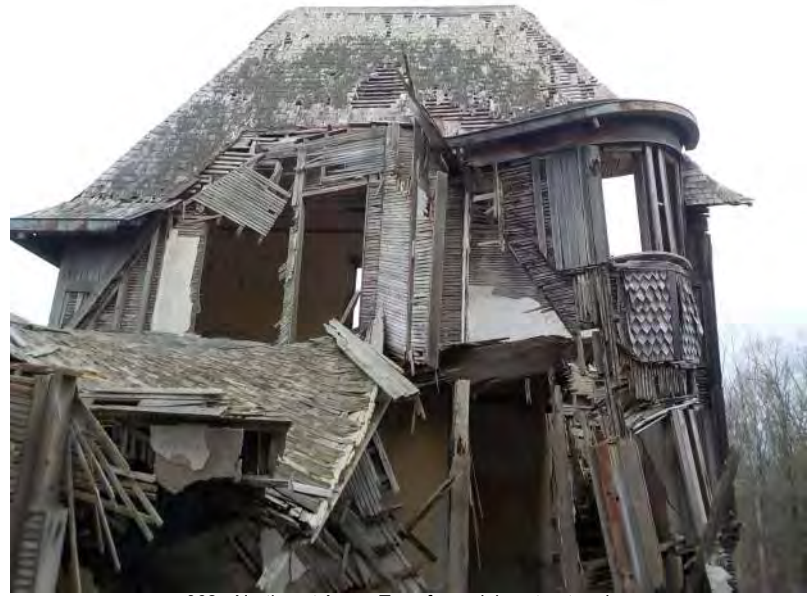
062 - Northeast Area - Top of remaining structure.jpg

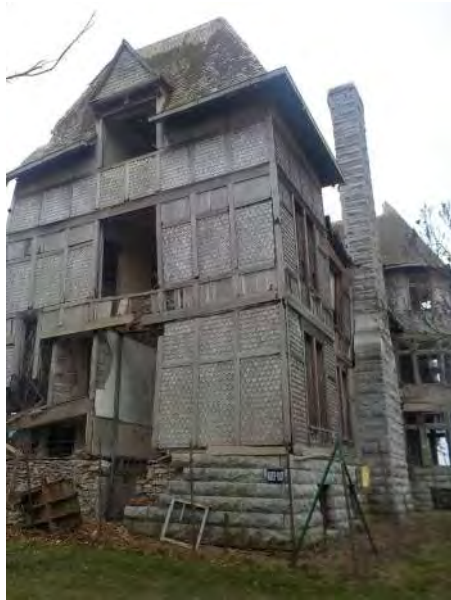
063 - Northeast Area - North corner 1.jpg

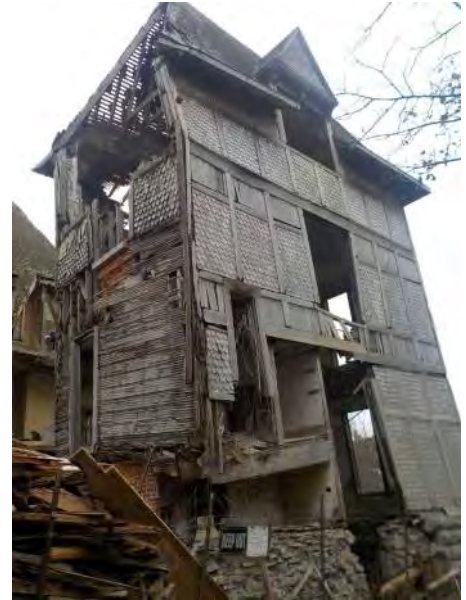
064 - Northeast Area - North corner 2.jpg

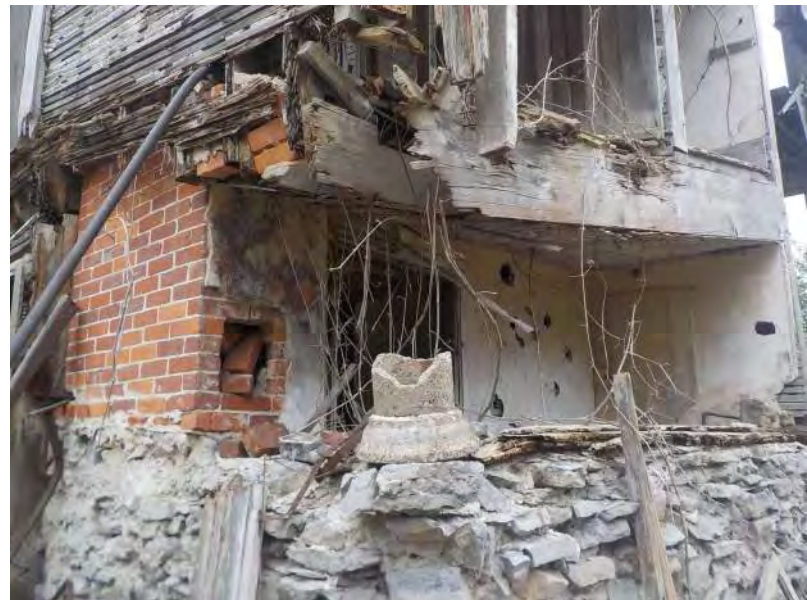
066 - Northeast Area - First floor level overview.jpg

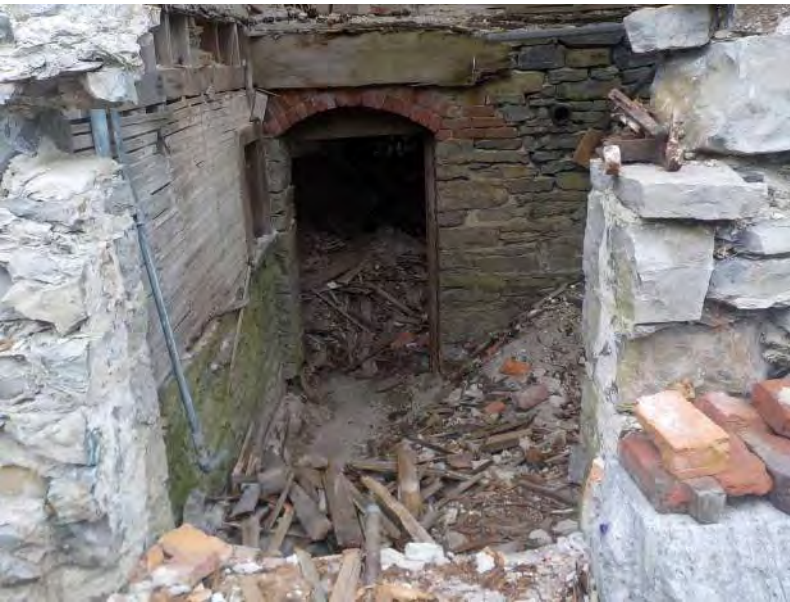
069 - Northeast Area - Basement walls 1.jpg

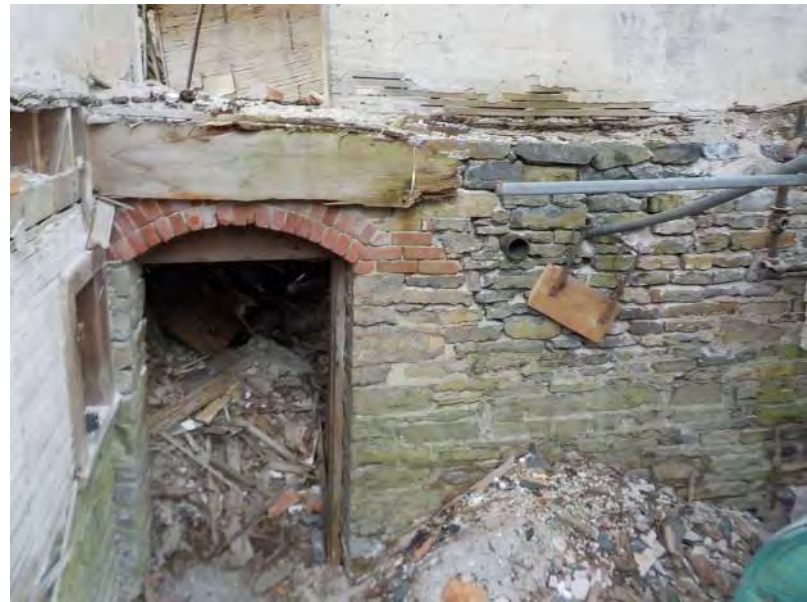
070 - Northeast Area - Basement walls 2.jpg

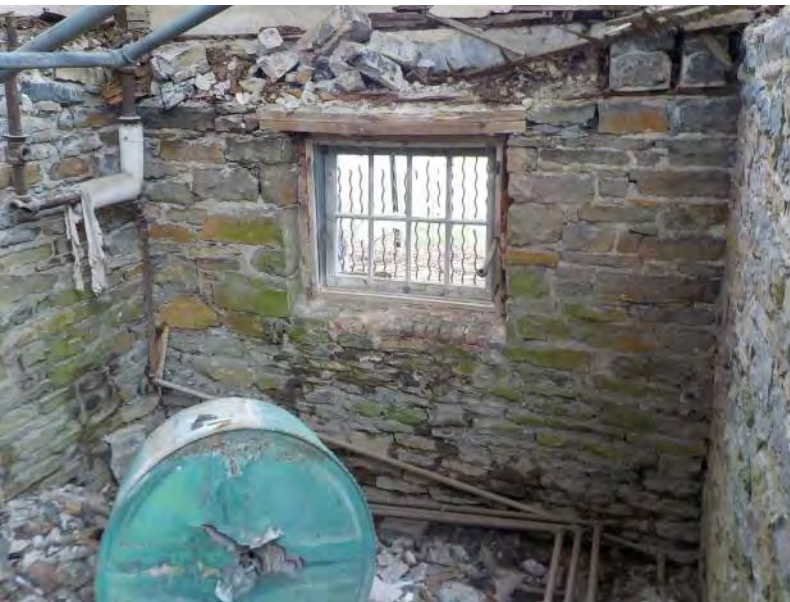
071 - Northeast Area - Basement walls 3.jpg

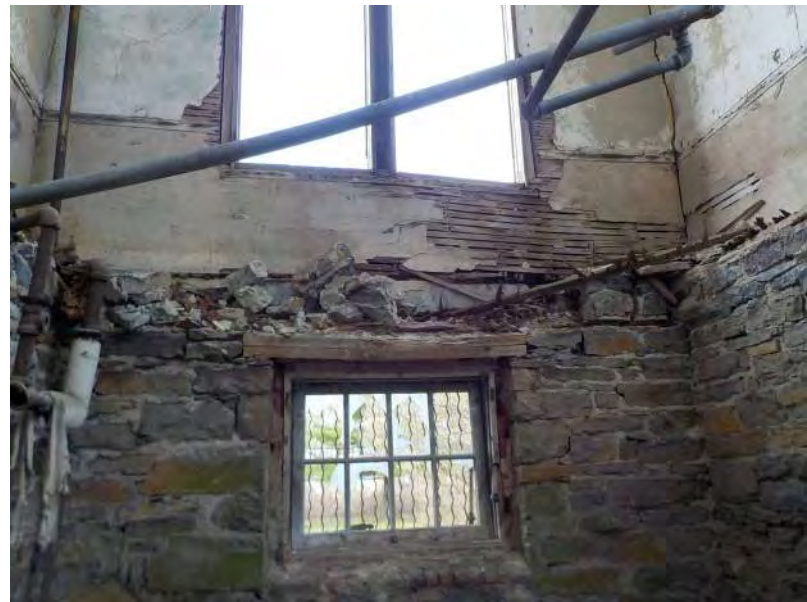
072 - Northeast Area - Inside face of basement wall.jpg

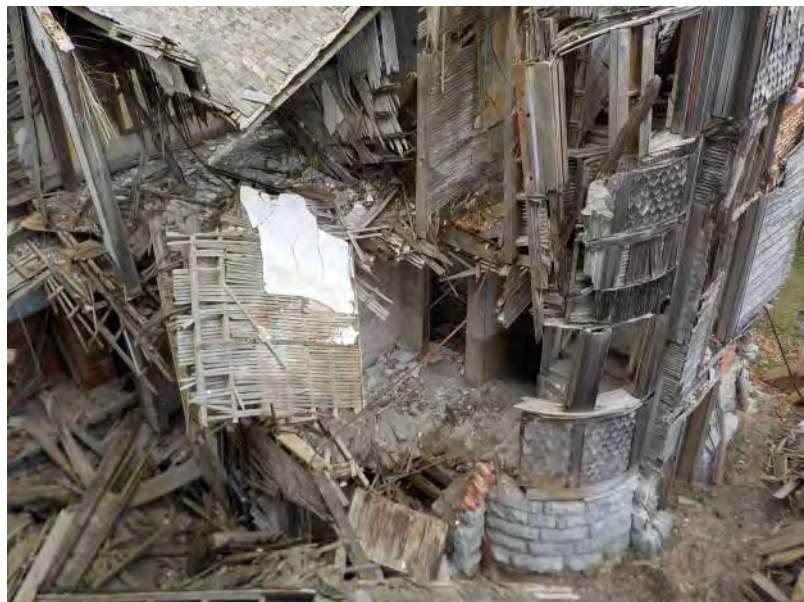
076 - Northeast Area - Collapsed section.jpg

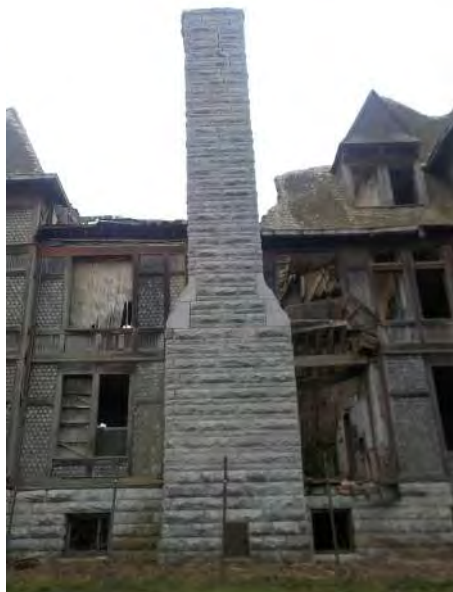
077 - Northeast Area - Chimney NW face.jpg

- 4.3.8 The faces of the fireplaces have deteriorated primarily due to the rusting and the flexibility of the steel bar lintels supporting the bricks over the firebox. The rest of the masonry chimneys seem to be in better shape and may be salvageable, however, the scope of our review did not include a review of the chimney interiors or flues.

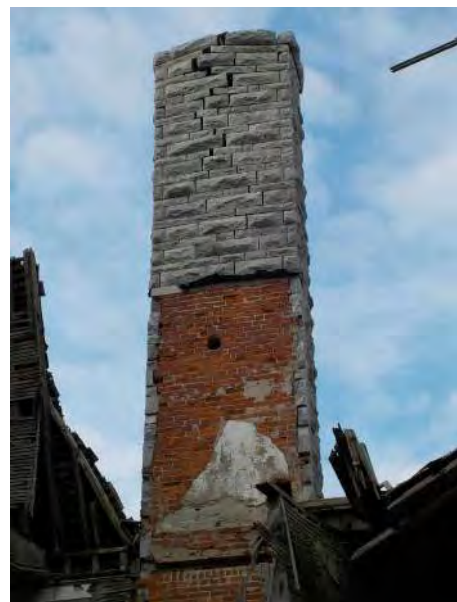
078 - Northeast Area - Chimney SE face 1.jpg

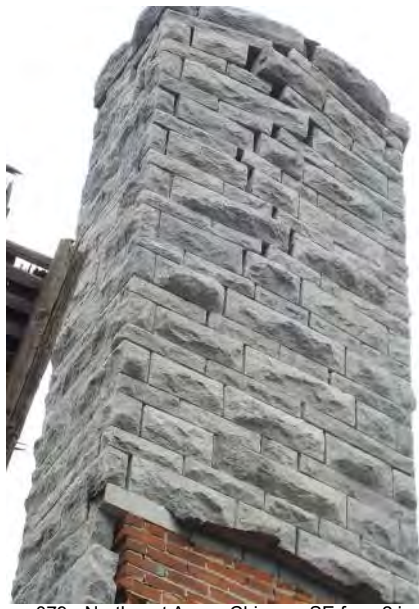
079 - Northeast Area - Chimney SE face 2.jpg

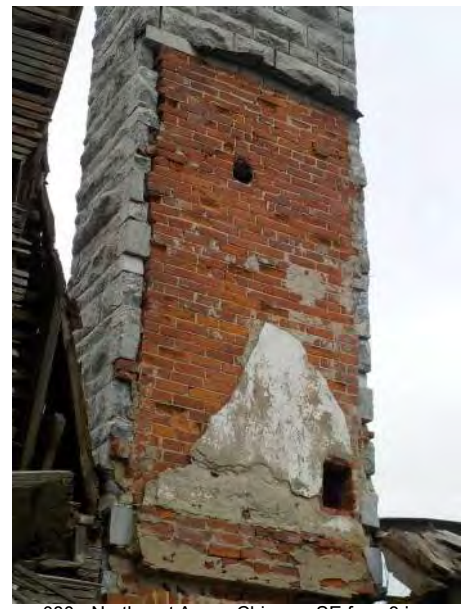
080 - Northeast Area - Chimney SE face 3.jpg

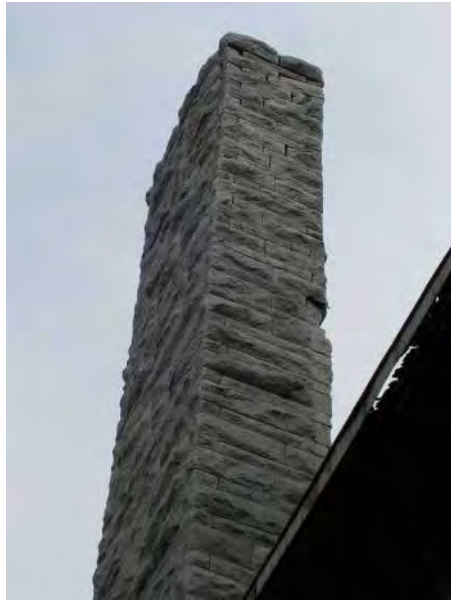
081 - Northeast Area - Chimney SW side.jpg

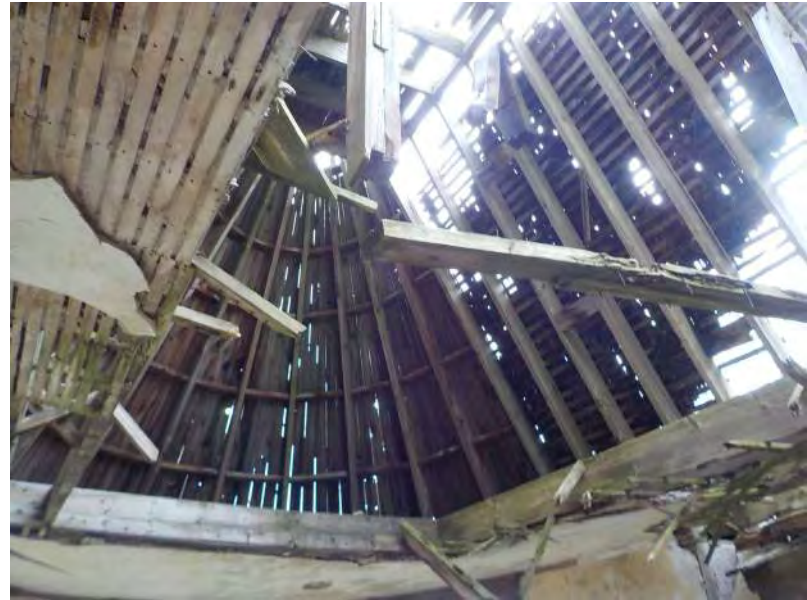
- 4.2.1 All of the wood roof framing, floor framing, and wall framing are moderately to severely deteriorated. Although a portion of the wood members might be able to be salvaged and reused, each piece would need to be reviewed to assess its condition to resist structural loading and new members or reinforcing elements would need to be added. It would be less time consuming and less costly to remove and replace 100% of the wood elements.

082 - Third Floor - Looking up at roof framing 1.jpg

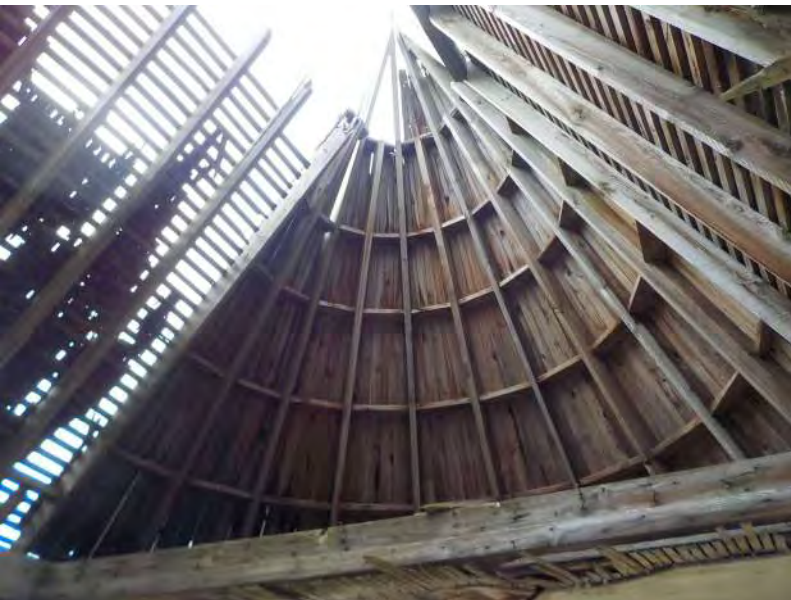
083 - Third Floor - Looking up at roof framing 2.jpg

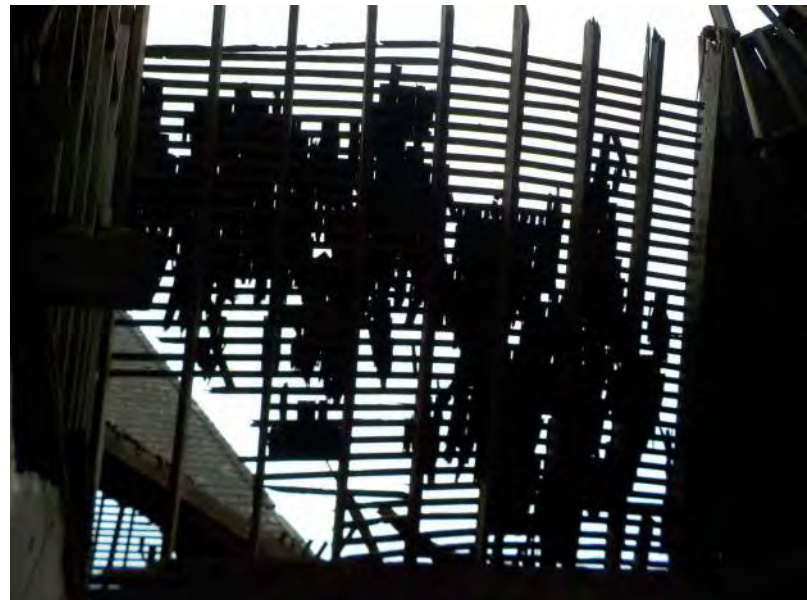
084 - Third Floor - Looking up at roof framing 3.jpg

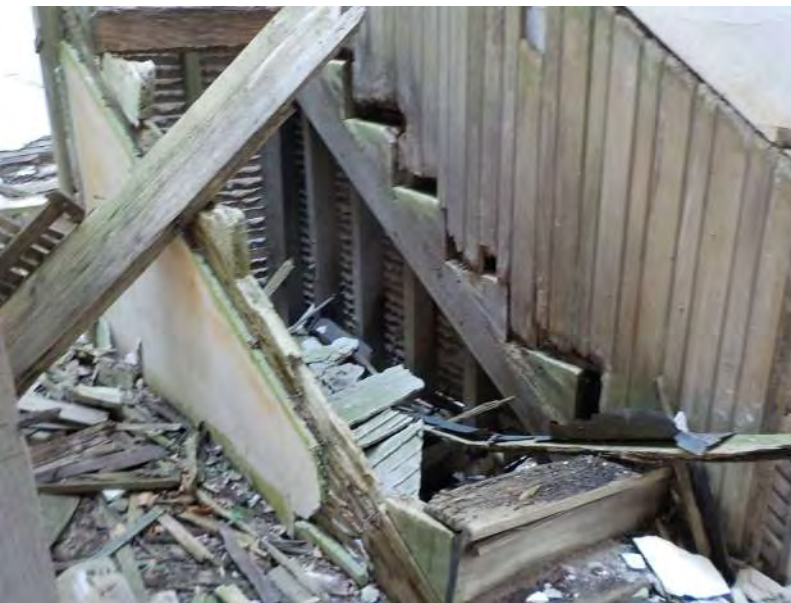
085 - Third Floor - Secondary staircase.jpg

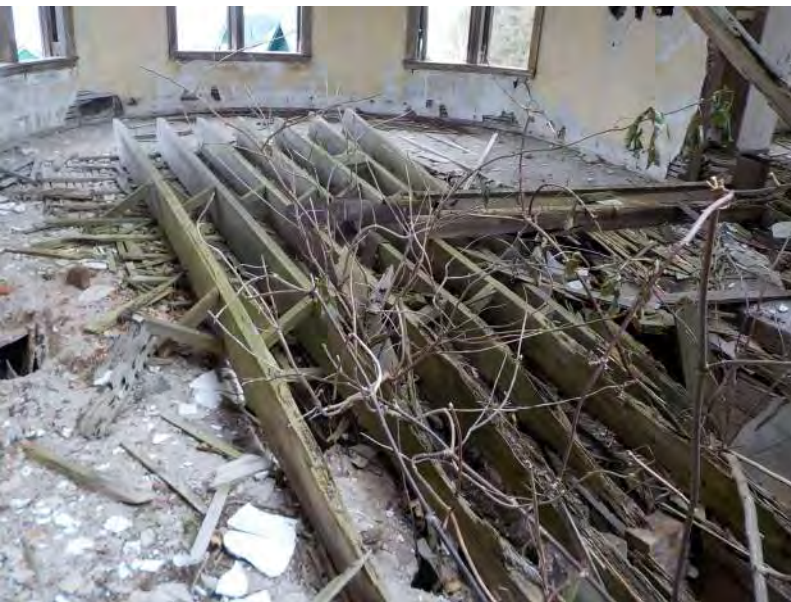
087 -Third Floor-Floor with fallen fourth floor framing1.jpg

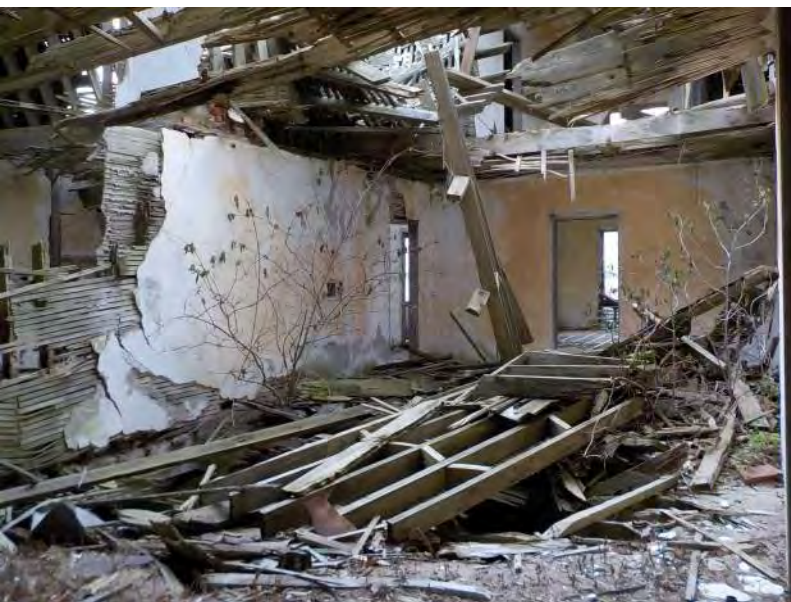
089 - Third Floor - Overview of central area.jpg

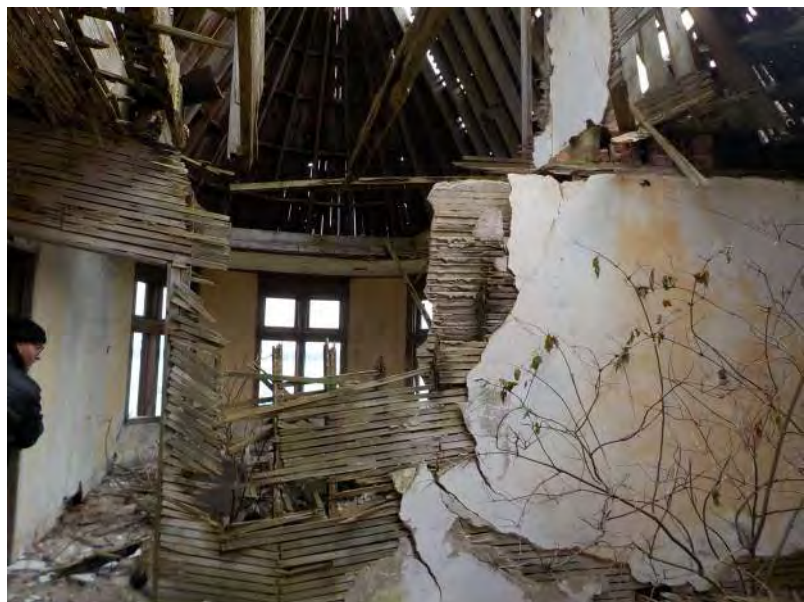
090 -Third Floor - Interior partitions.jpg

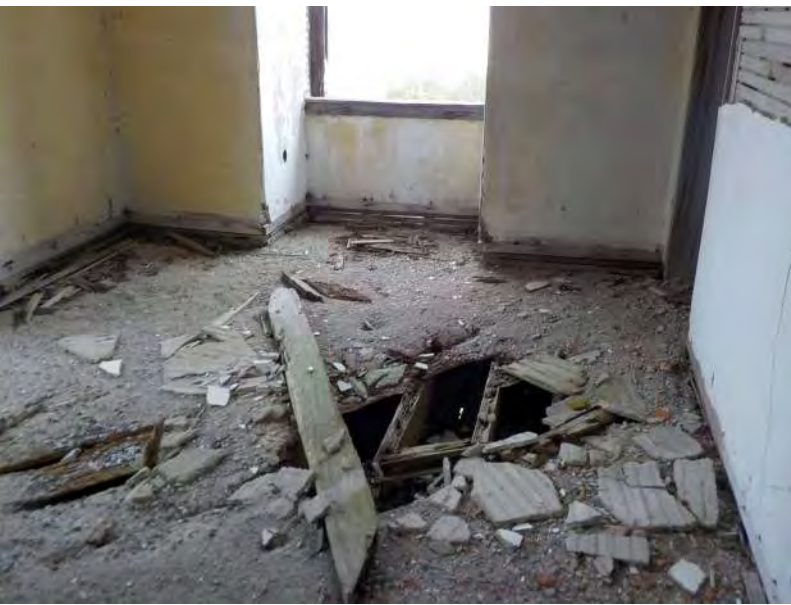
091 - Third Floor - Overview of floor 1.jpg

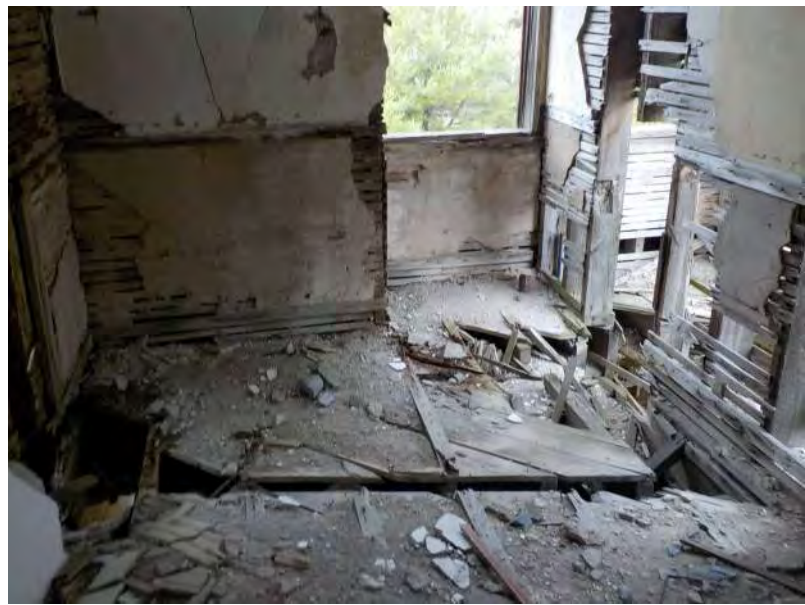
092 - Third Floor - Overview of floor 2.jpg

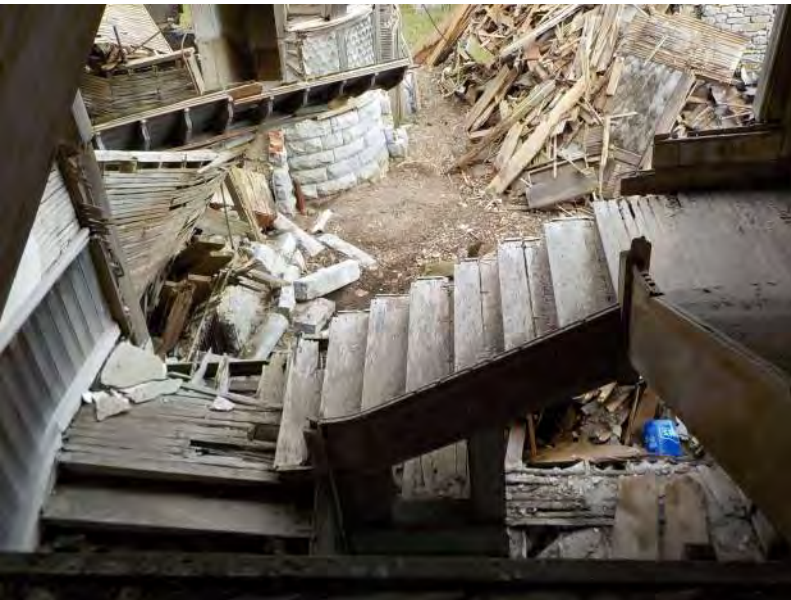
093 - Third Floor - Looking down staircase.jpg

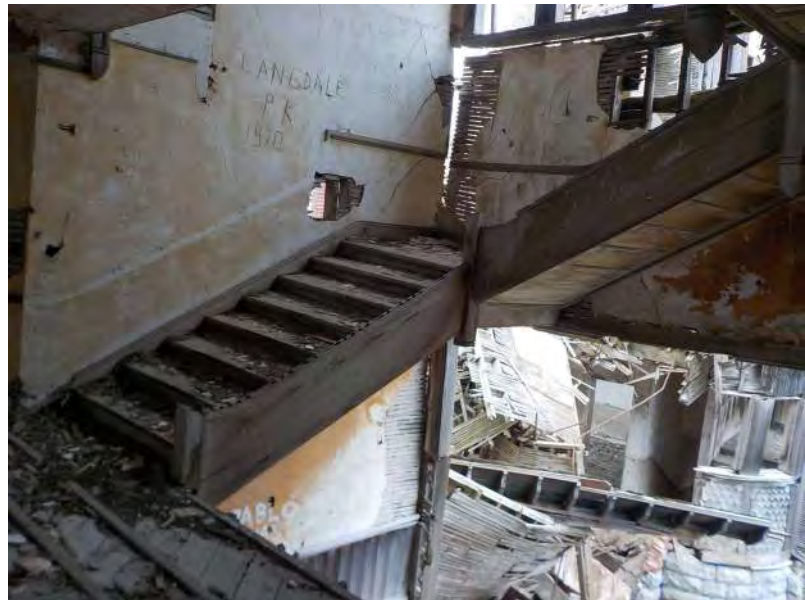
094 - Second Floor - Staircase to 3rd floor 1.jpg

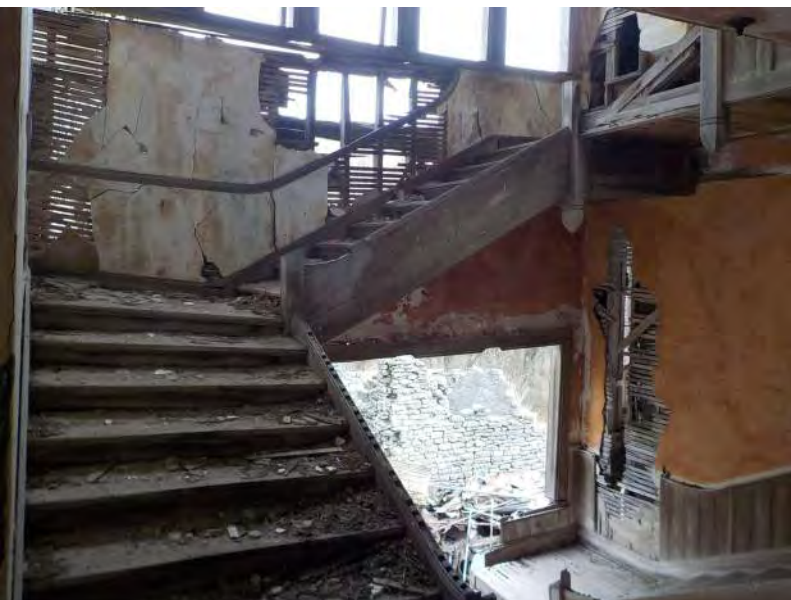
095 - Second Floor - Staircase to 3rd floor 2.jpg

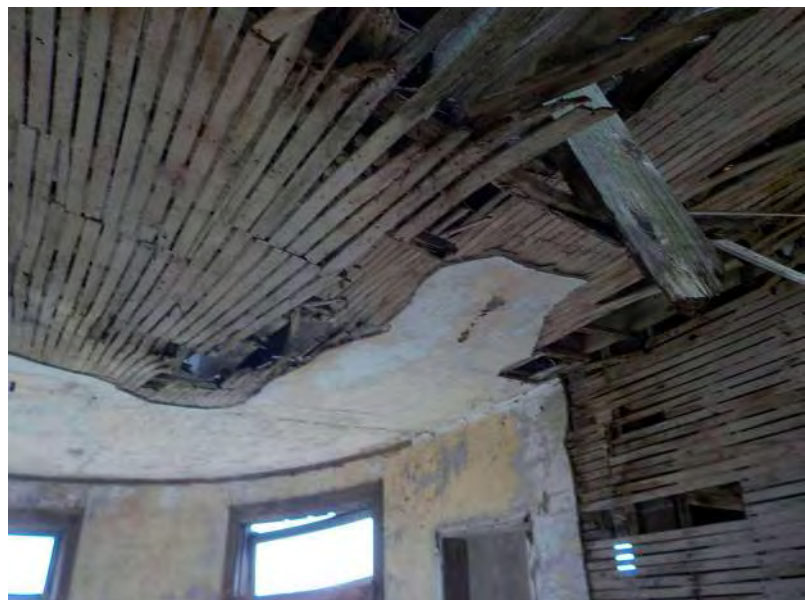
096 - Second Floor - Overview of ceiling.jpg

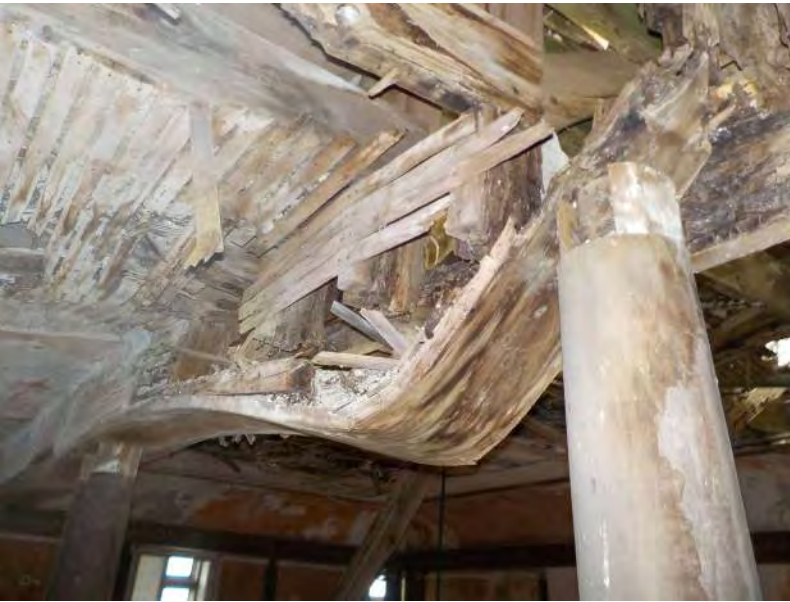
097 - Distressed 3rd floor beam from 2nd floor.jpg

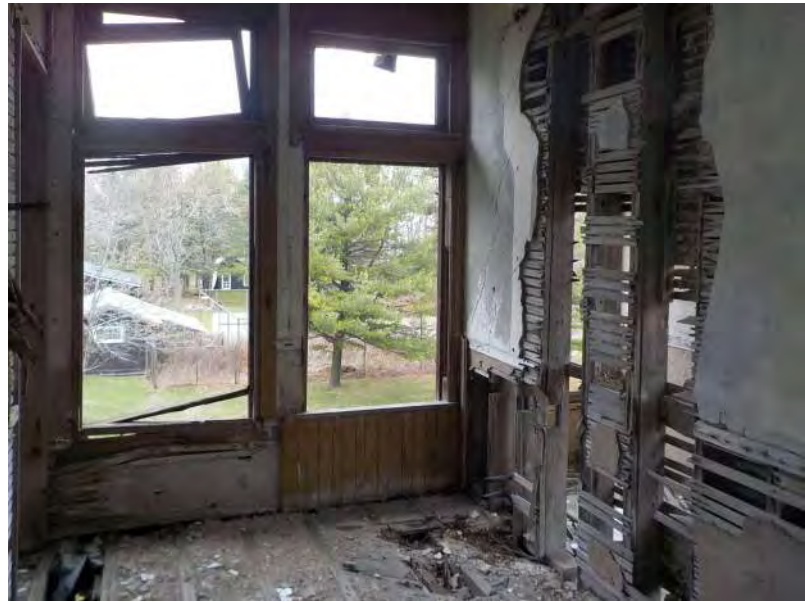
098 - Second floor deteriorated walls.jpg

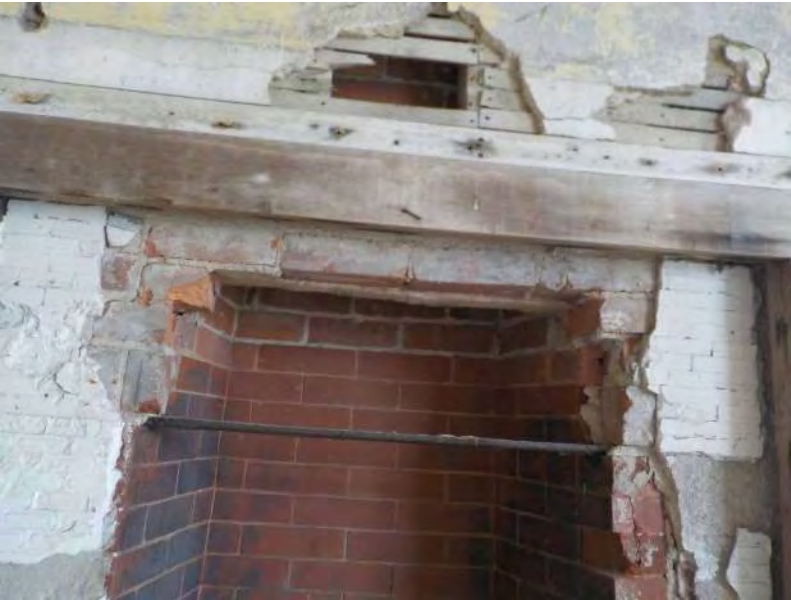
105 - Second Floor - Fireplace 2.jpg

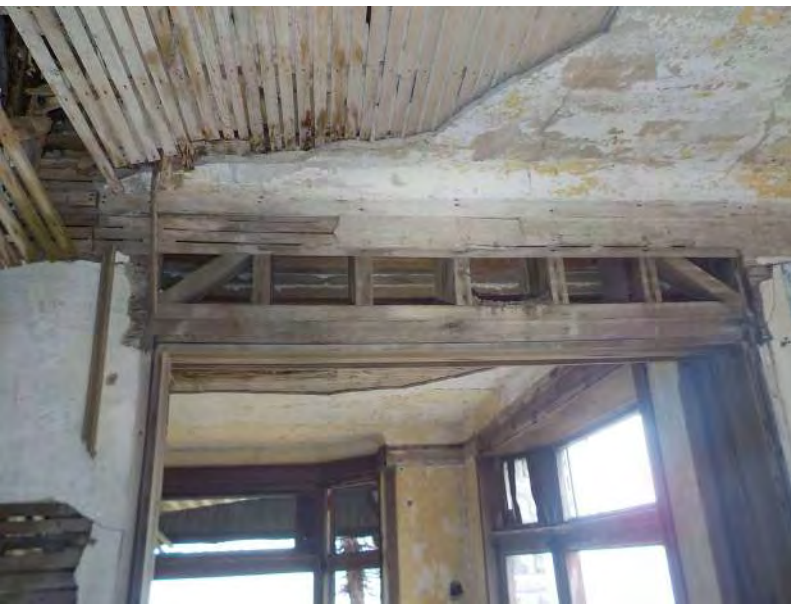
- 4.3.5 The sagging wood plank lintels may have always been structurally minimal. The deterioration of the mortar joints in the stone masonry above the planks has significantly weakened the lintels since the intact mortared masonry provided some amount of spanning capacity.

121 - First Floor - Wall opening header 12.jpg

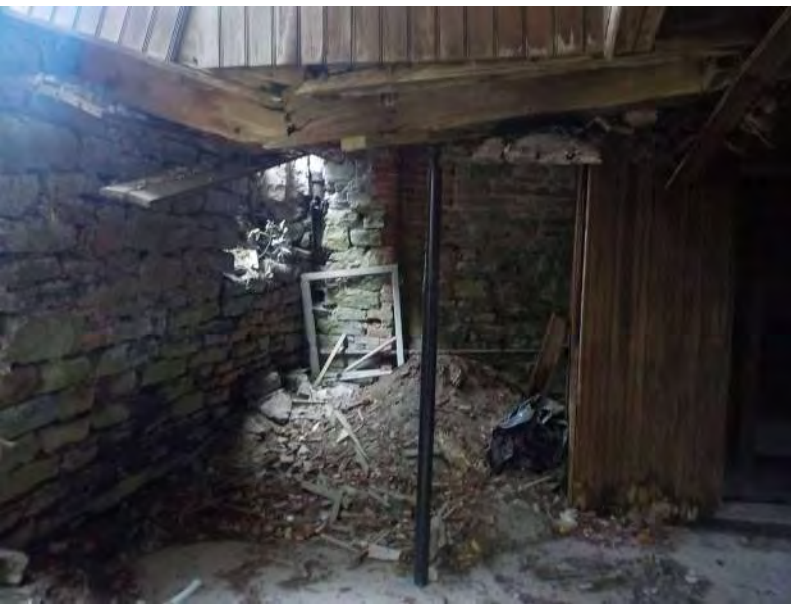
139 - Basement - First floor shoring near stairs.jpg

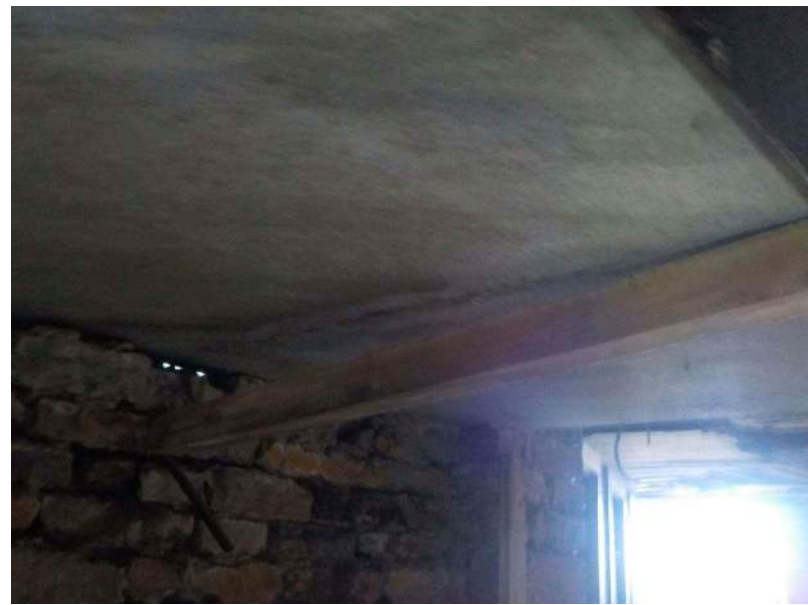
140 - Basement - Supports under stone floor at SE entrance.jpg

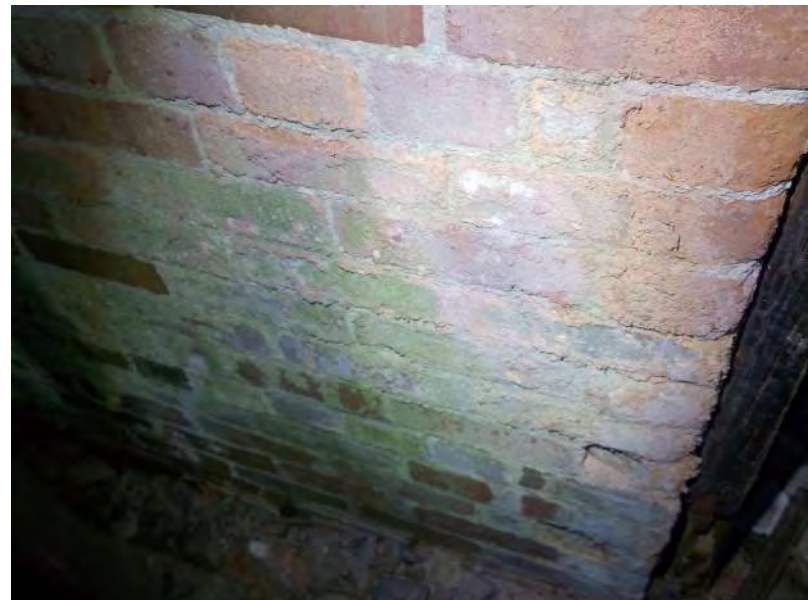
144 - Basement - Exfoliated brick wall near staircase.jpg

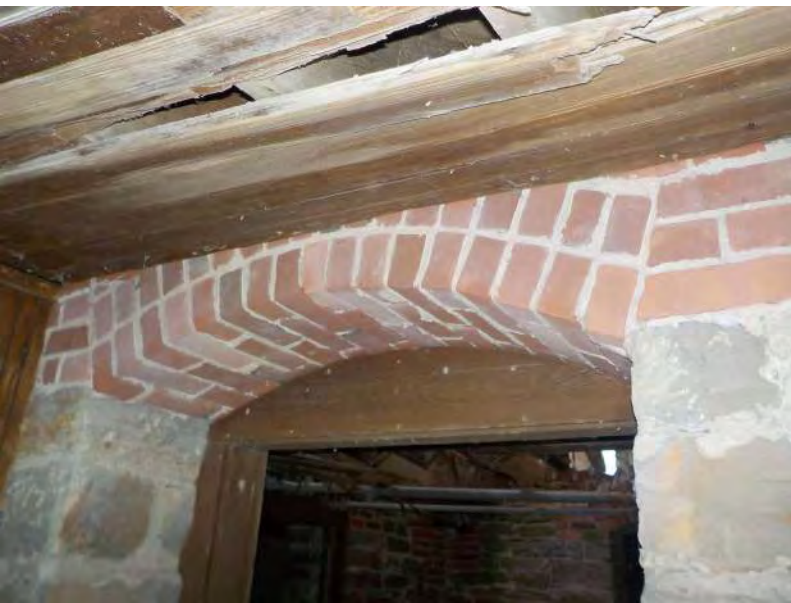
- 4.3.3 The cracked stones and missing pieces of stone represent compromised conditions and may have been caused by shifting from uneven supports.
- 4.3.4 The brick arches are not significantly structurally diminished, with the exception of localized wall deterioration at the ends of some of the arches.

145 - Basement - Arch over opening 1.jpg

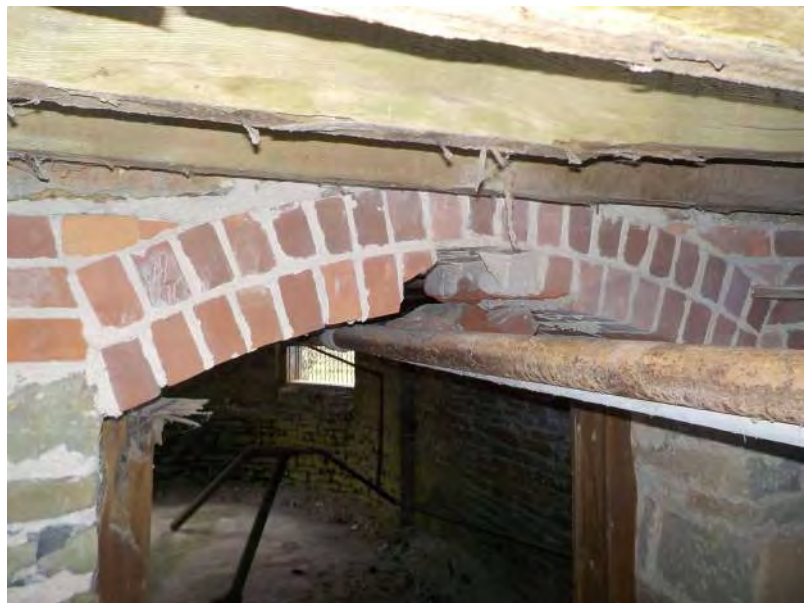
146 - Basement - Arch over opening 2.jpg

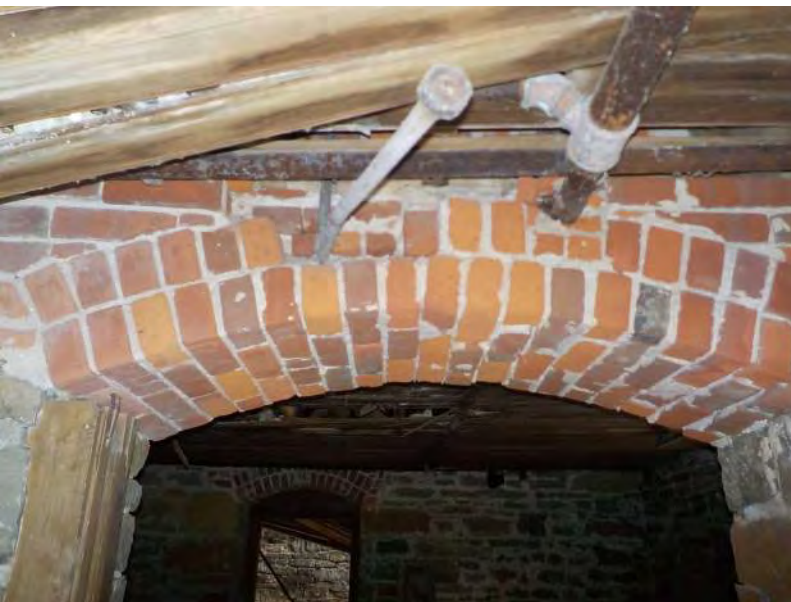
147 - Basement - Arch over opening 3.jpg

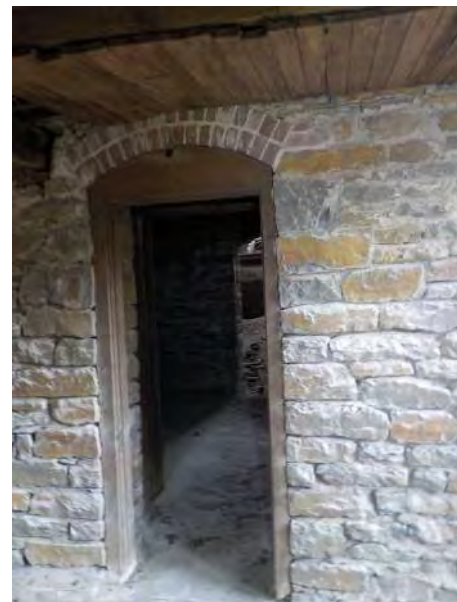
148 - Basement wall and opening arch 3.jpg

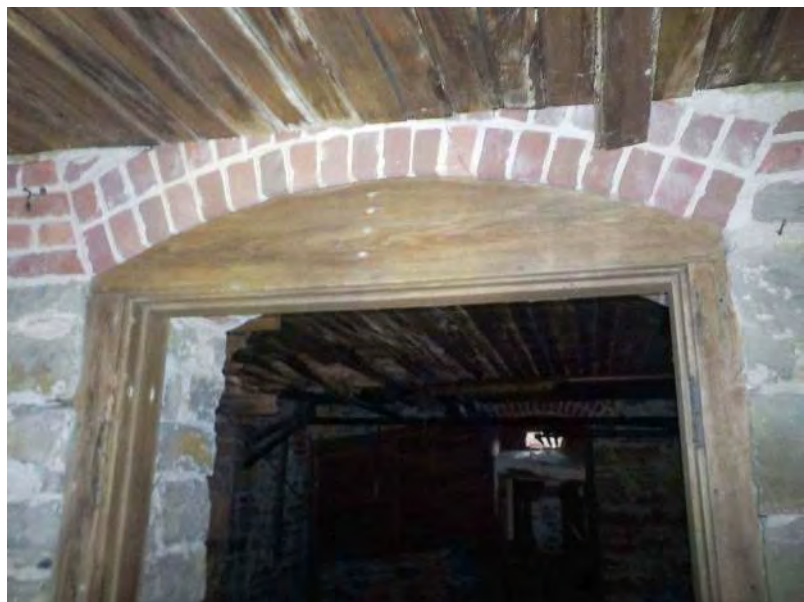
149 - Basement - Arch over opening 4.jpg

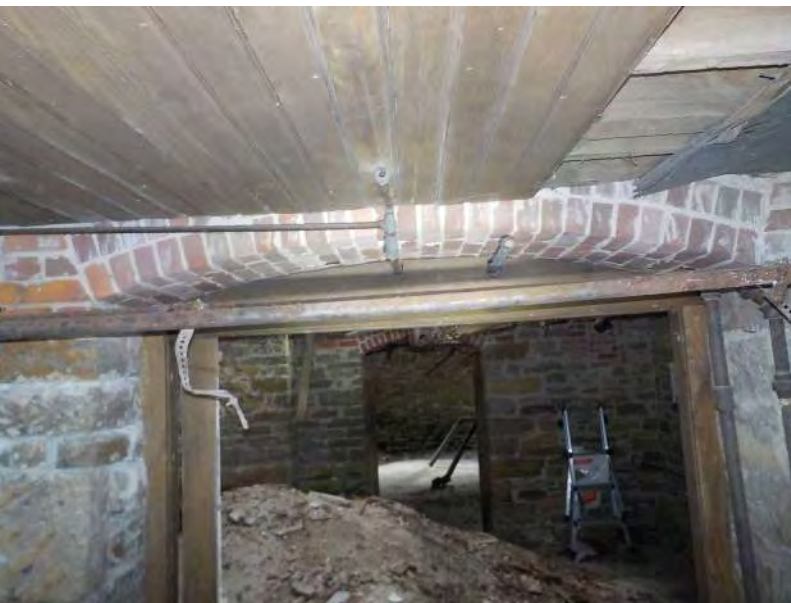
150 - Basement - Arch over opening 5.jpg

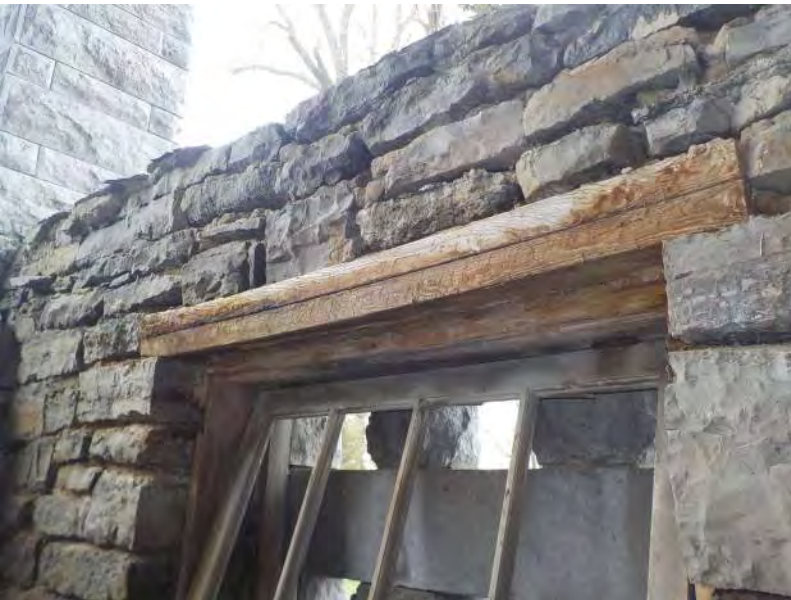
152 - Basement - Wood plank lintel over opening 1.jpg

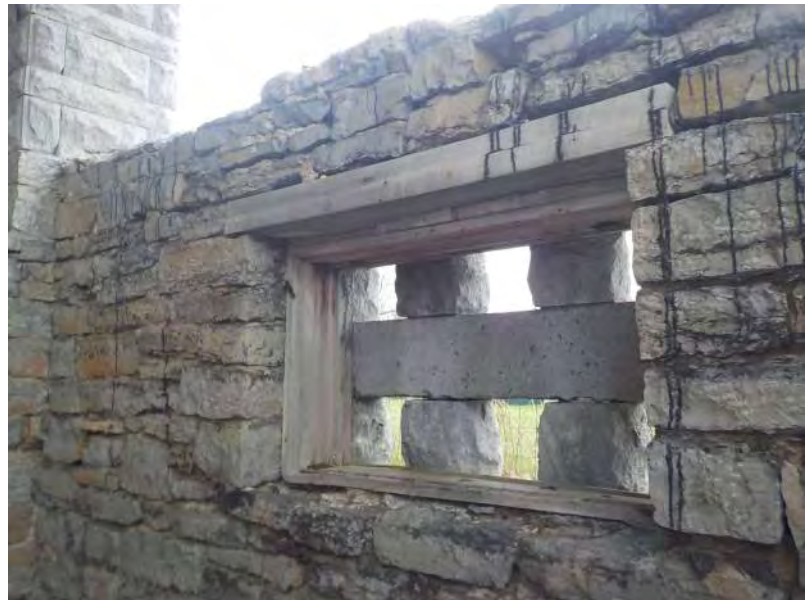
153 - Basement - Wood plank lintel over opening 2.jpg
