STRUCTURAL CONDITION REVIEW REPORT

DATE: 28 December 2022

PROPERTY: Carleton Villa, Carleton Island, Cape Vincent, NY

KHH NO: 122087

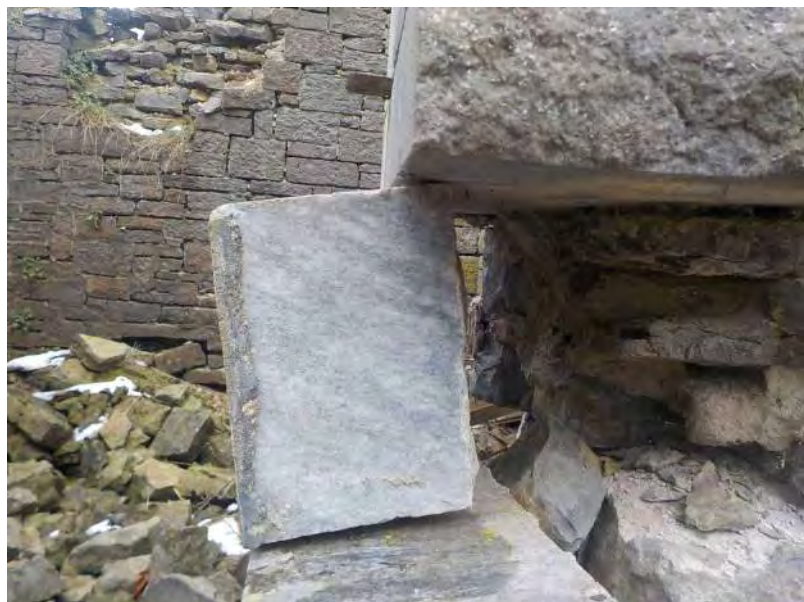
060 - Northeast Area - NE stone arch base.jpg

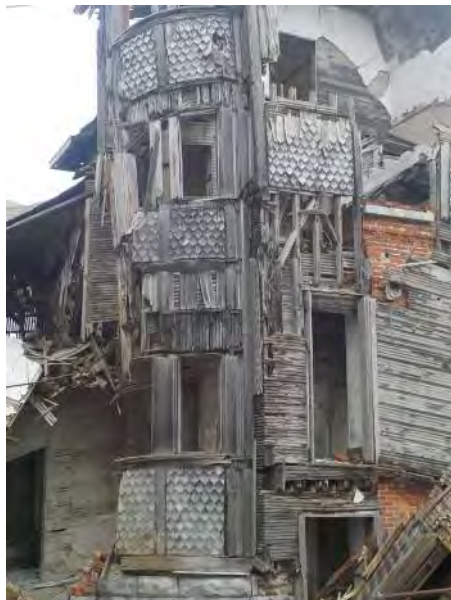
065 - Northeast Area - Exterior overview 1.jpg

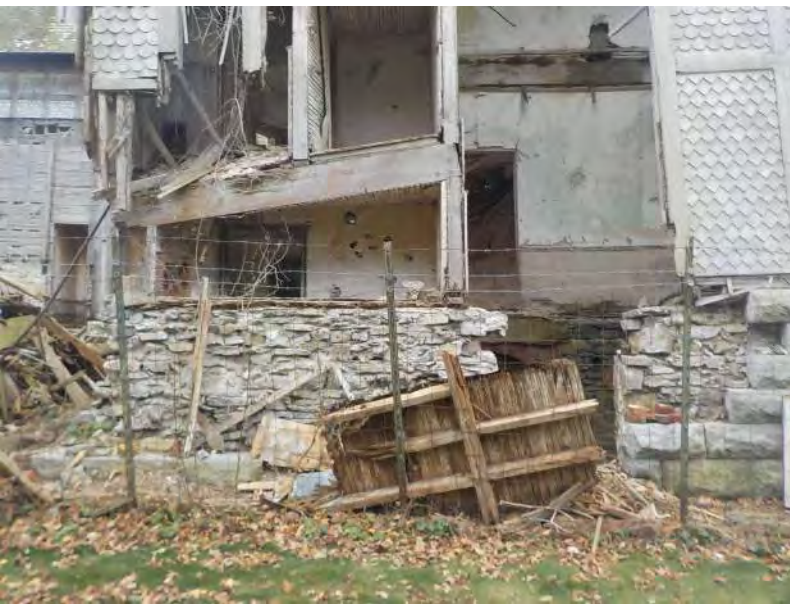
067 - Northeast Area - NE face at grade.jpg

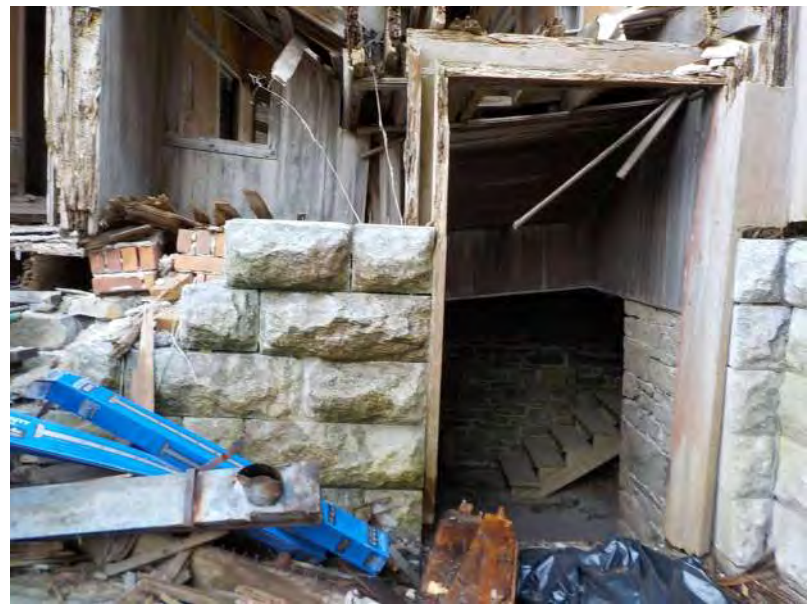
068 - Northeast Area - Grade-level wall.jpg

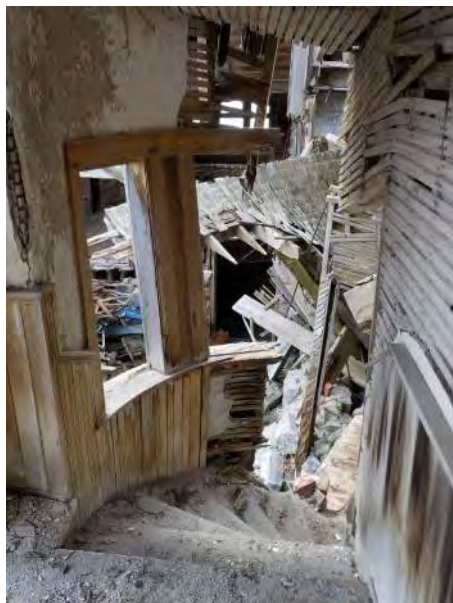
073 - Northeast Area - Spiral staircase area 1.jpg

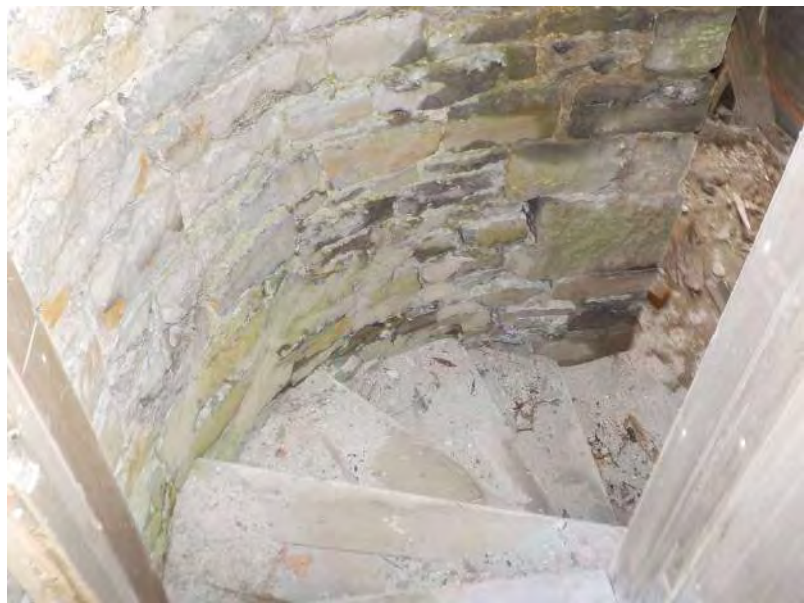
074 - Northeast Area - Spiral staircase area 2.jpg

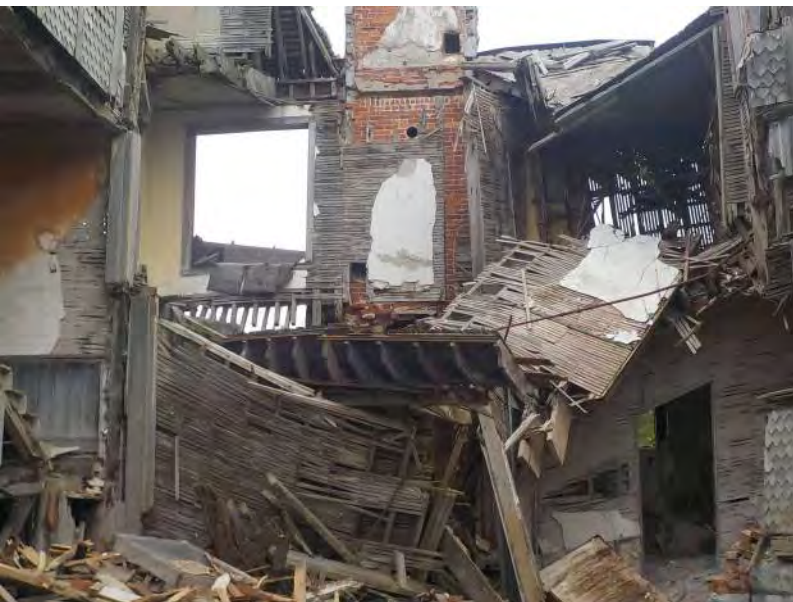
075 - Northeast Area - Overview.jpg

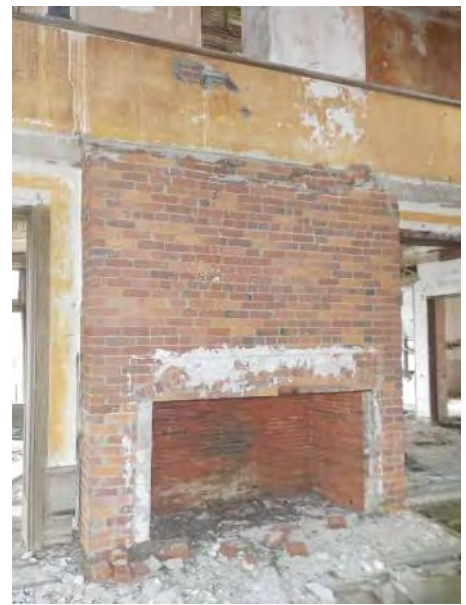
- 4.3.8 The faces of the fireplaces have deteriorated primarily due to the rusting and the flexibility of the steel bar lintels supporting the bricks over the firebox. The rest of the masonry chimneys seem to be in better shape and may be salvageable, however, the scope of our review did not include a review of the chimney interiors or flues.

122 - First Floor - Fireplace 1.jpg

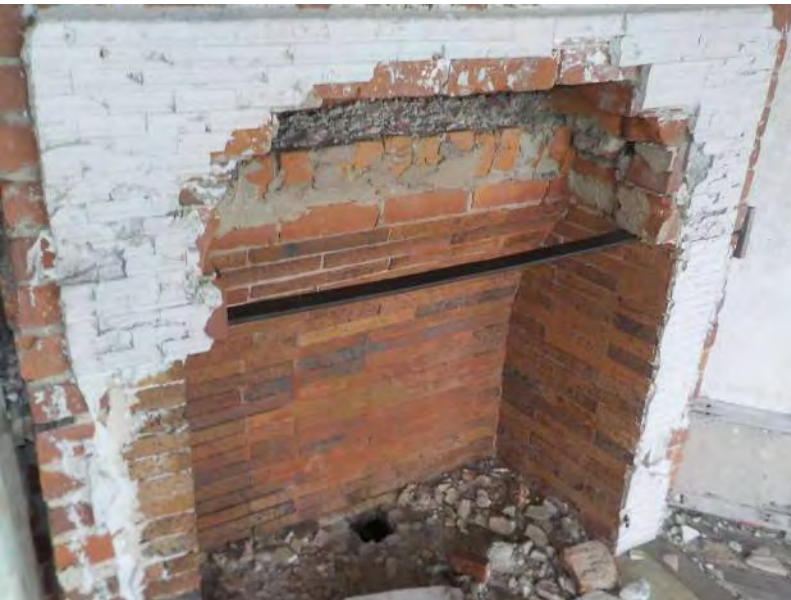
123 - First Floor - Fireplace 2.jpg

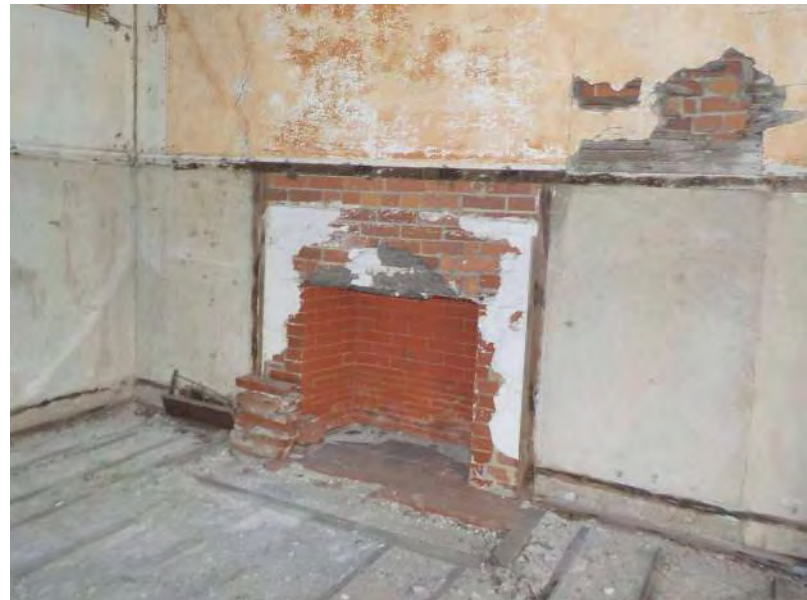
124 - First Floor - Fireplace 3.jpg

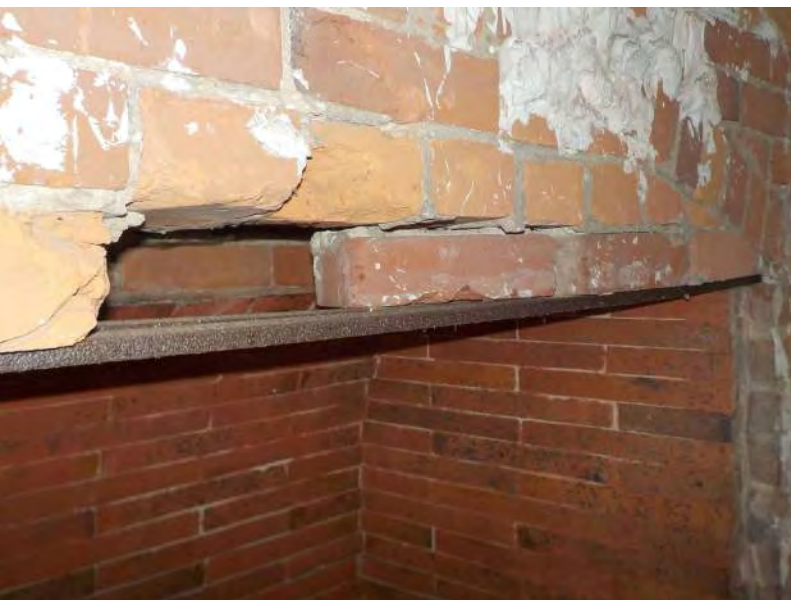
125 - First Floor - Fireplace 4.jpg

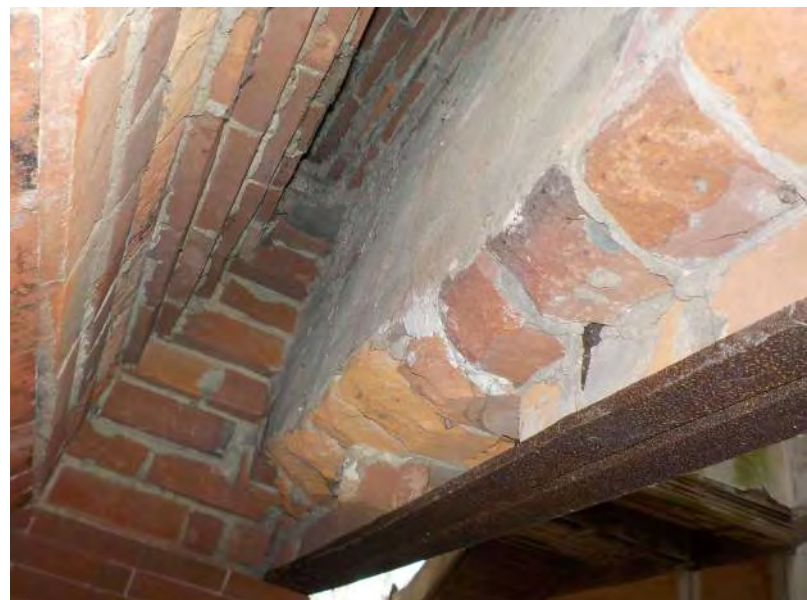
126 - First Floor - Fireplace 5.jpg
